UNI-3262

April 17, 1986

RIVER DISCHARGE LINES CHARACTERIZATION REPORT

J. F. Beckstrom, J. M. Steffes

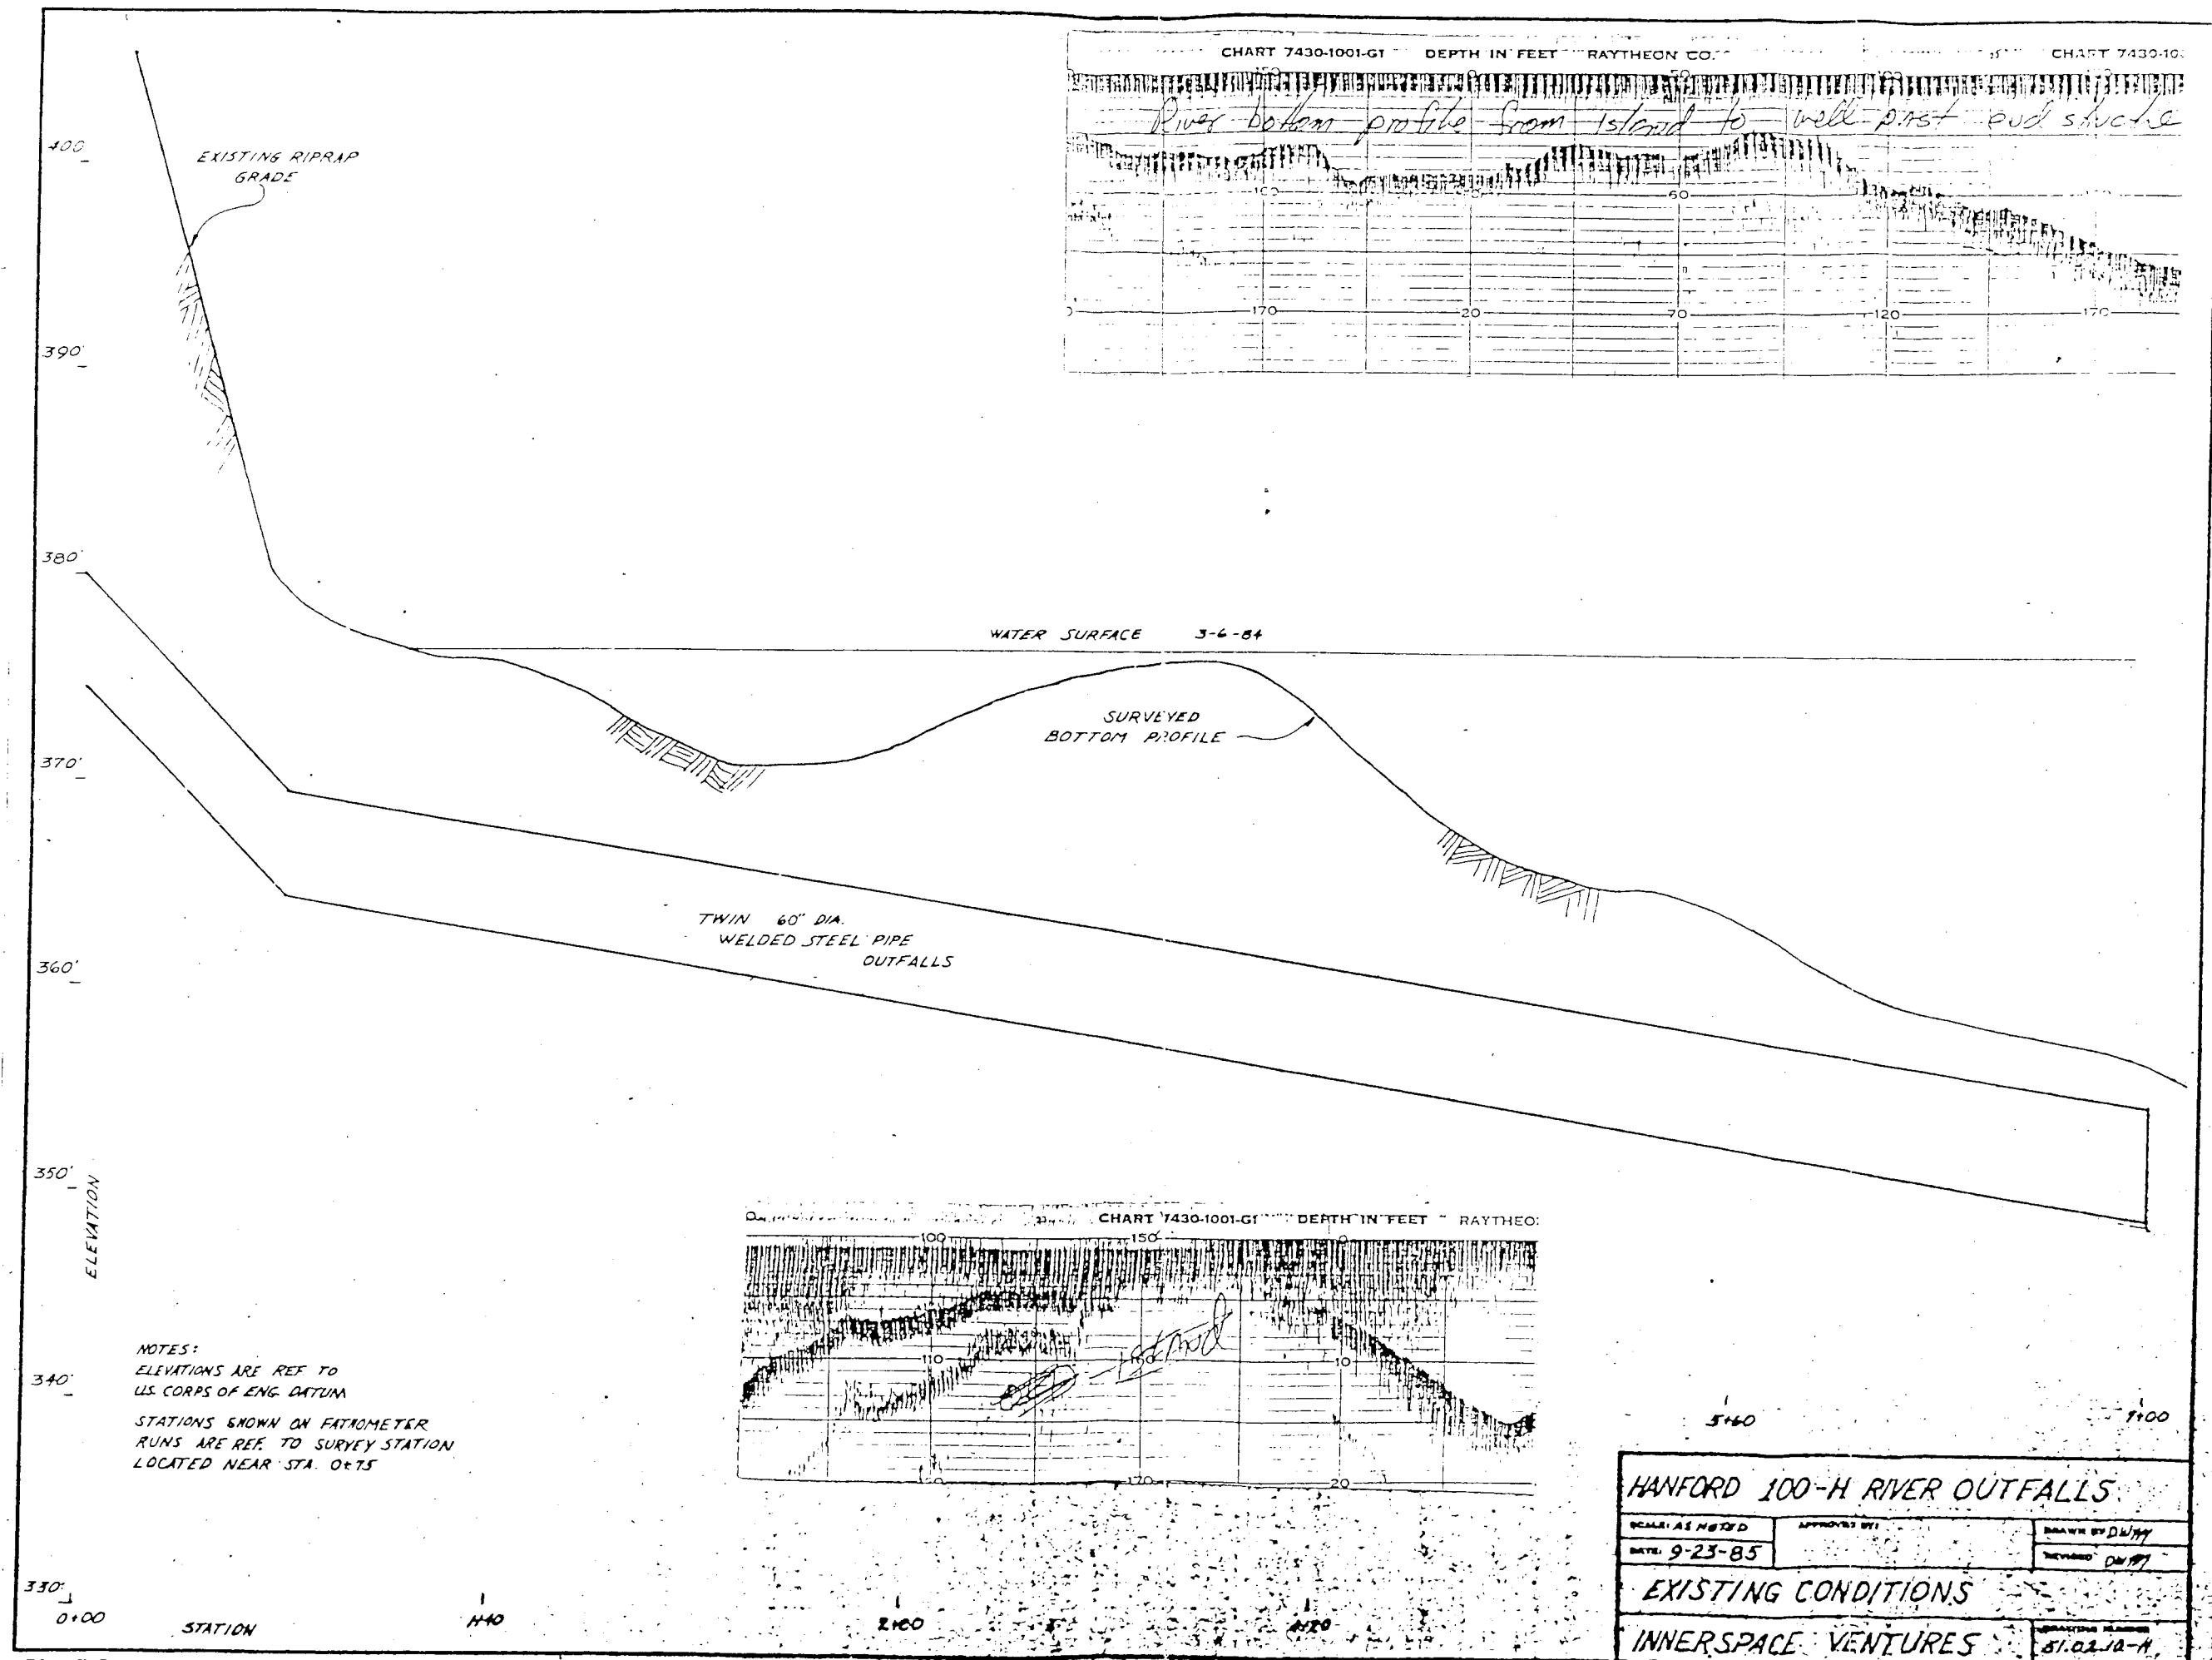
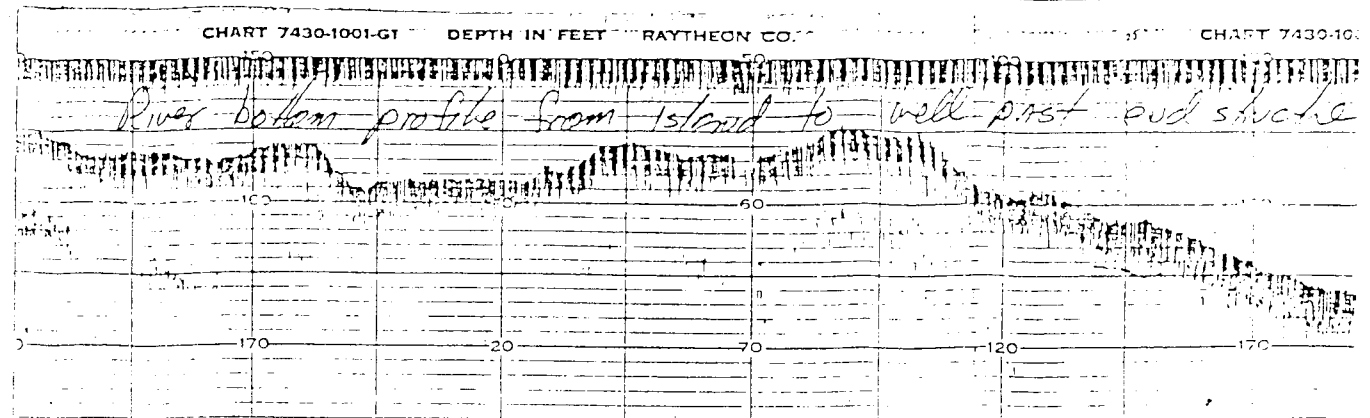
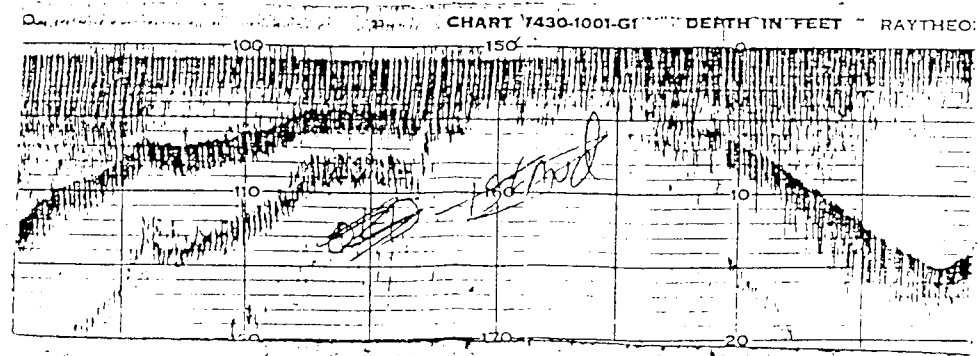
| HANFORD 100-H RIVER OUTFALLS | | |

4. The H area pipeline is nowhere exposed to the river flow and is therefore structurally stable in its present environment.
5. Should further investigations be undertaken, it is strongly recommended that such investigations be conducted from heavy floating equipment where a diver can be placed in the water in a crane bucket and maneuvered from the surface. Our investigations were aided by an unprecedented reduction of river flow which cannot be counted on again to facilitate lightweight surface support craft. Any further attempts to free dive in areas which may require additional surveys would be tricky at best and in the case of the DR area quite inadvisable.

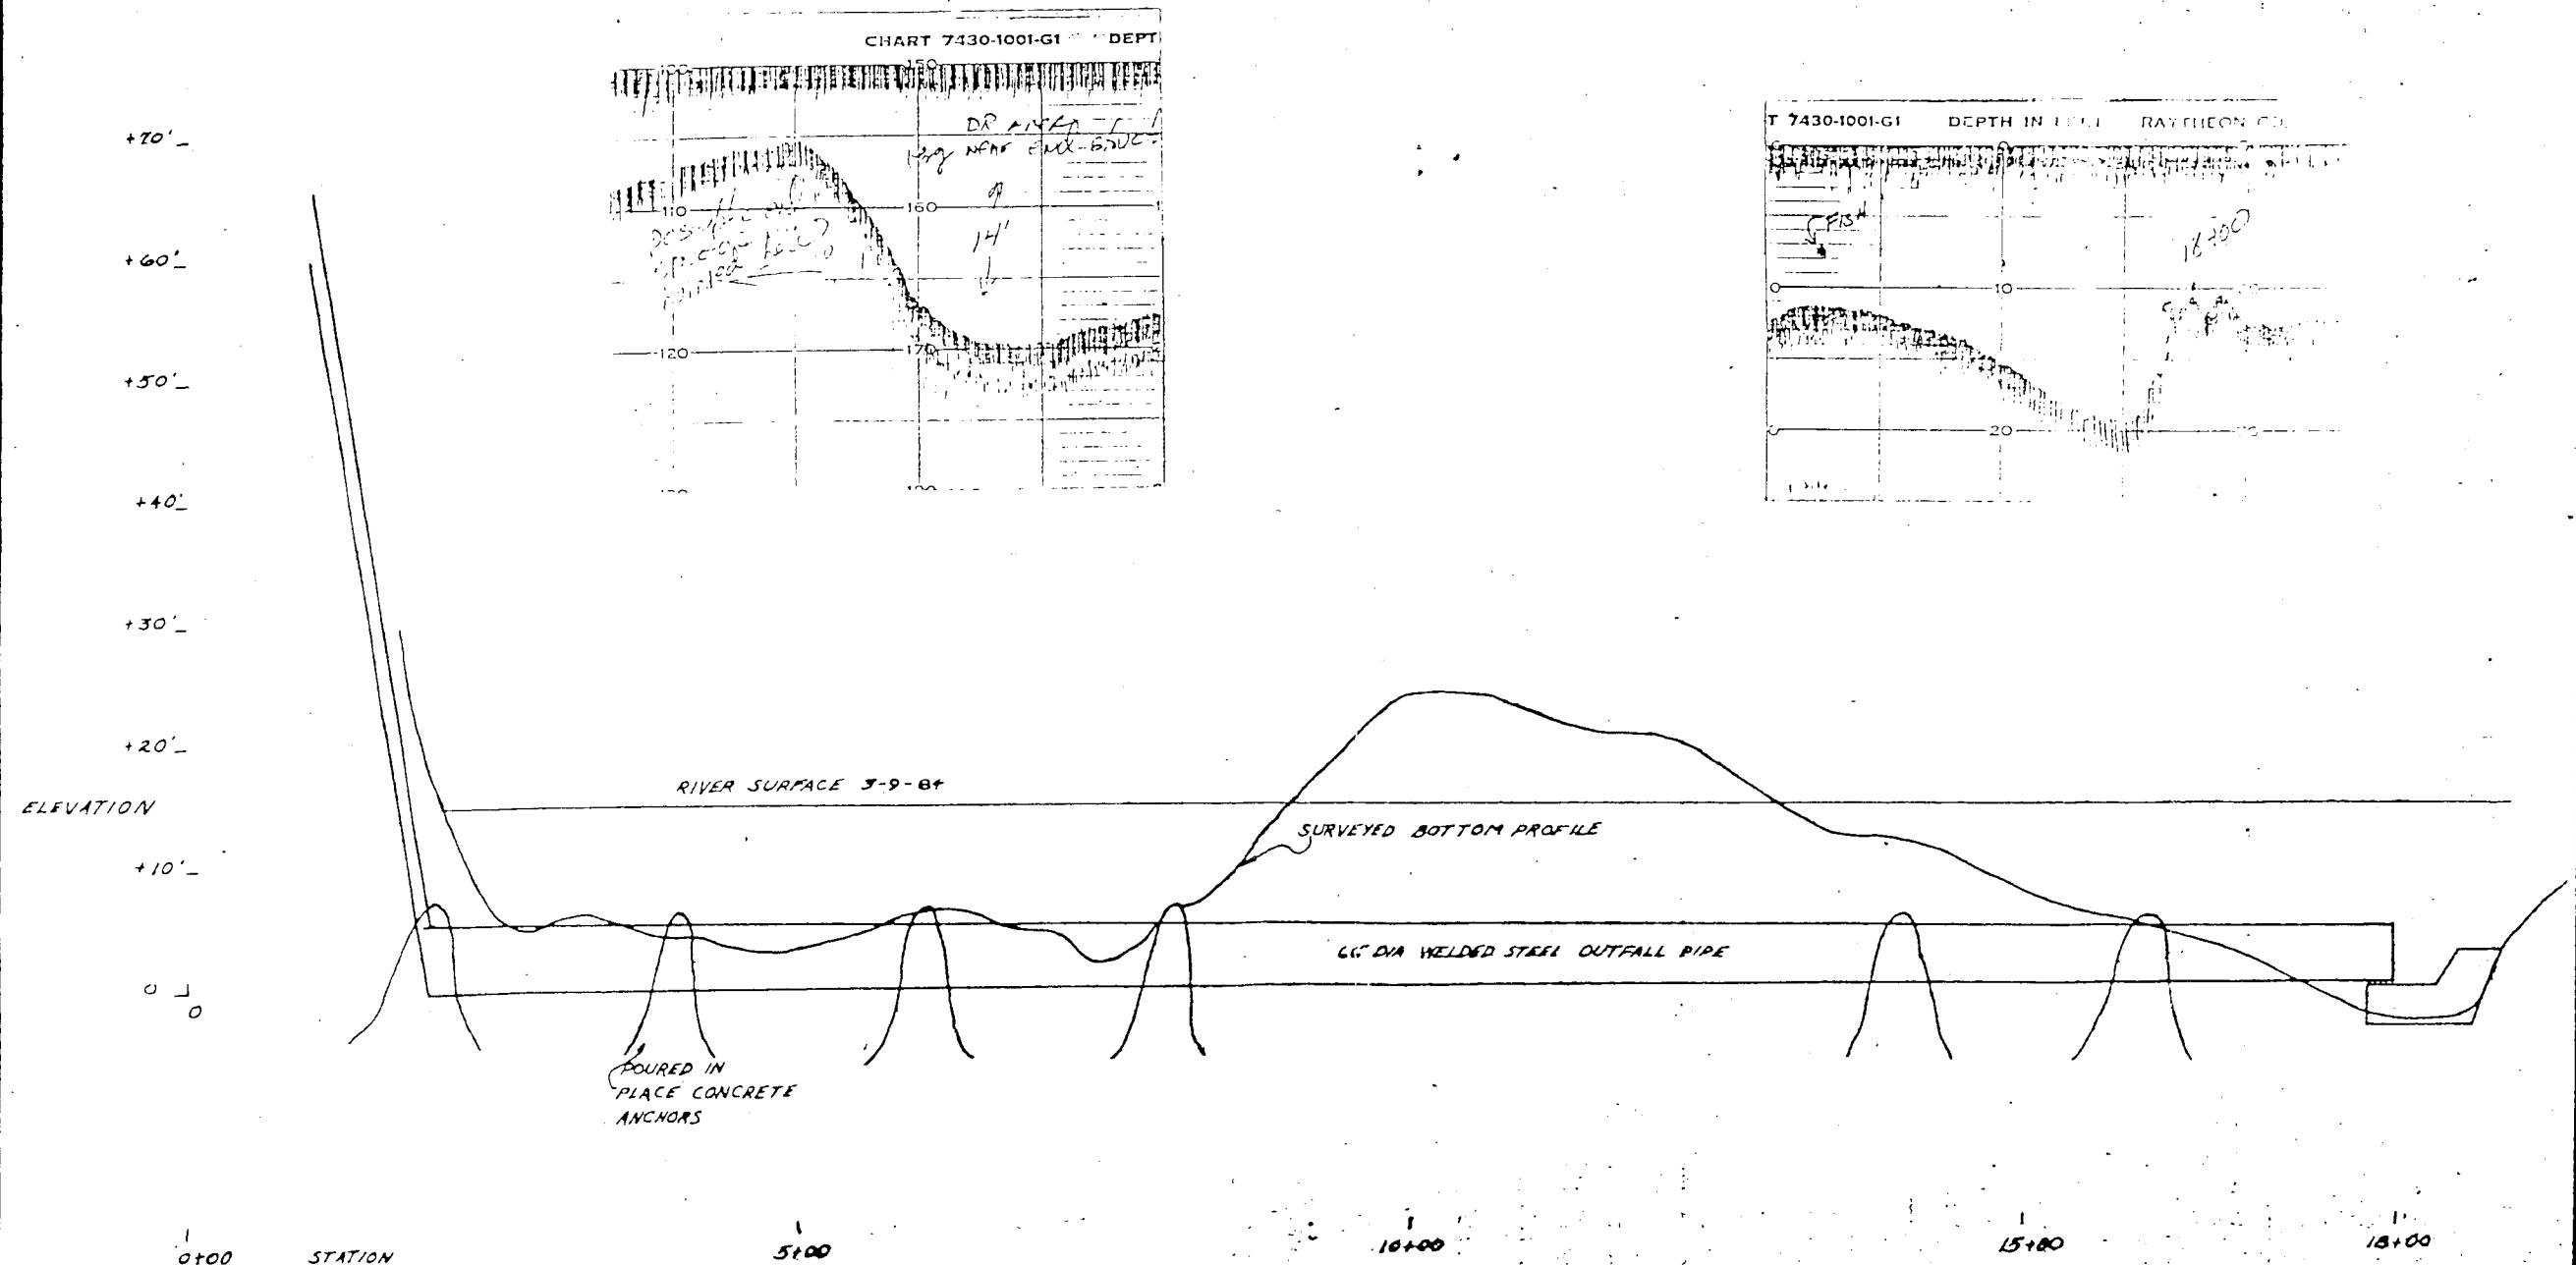
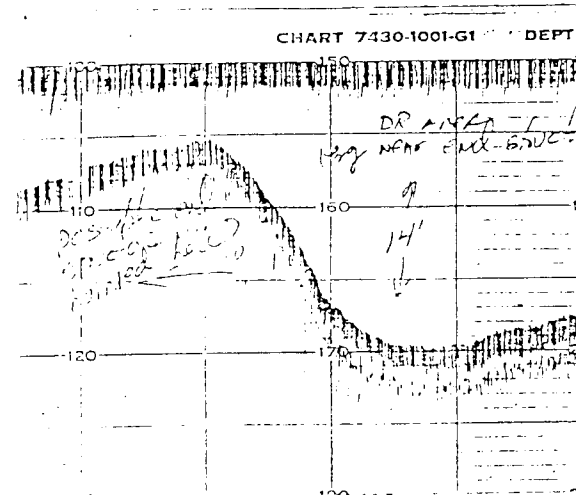
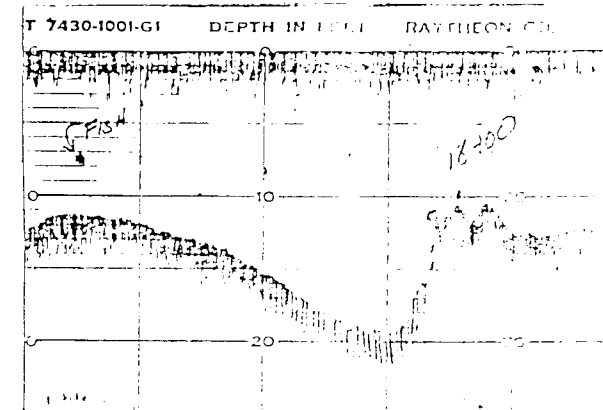
| HANFORD 100-DR RIVER OUTFALL | | |

2. The DR area Discharge lines are completely exposed to the river flow in areas inshore of the island. Although no large sections of the pipe offshore of the island are exposed, the scour bowl/sediment trap discontinuity induces extremely violent current disturbances which are definite hazards to navigation in the immediate area. Those exposed sections inshore of the island, are not subjected to the high mainstream currents and therefore do not present as great a hazard. However, this area of pipe is subject to lateral loading induced by the river's currents.
